March 20, 2009

HOME INSPECTION REPORT
Berkeley Heights Street Address Removed
Berkeley Heights, NJ

The following are the findings of a **Home Inspection** of the subject property done on March 17, 2009. This report is for the use of Client name removed.

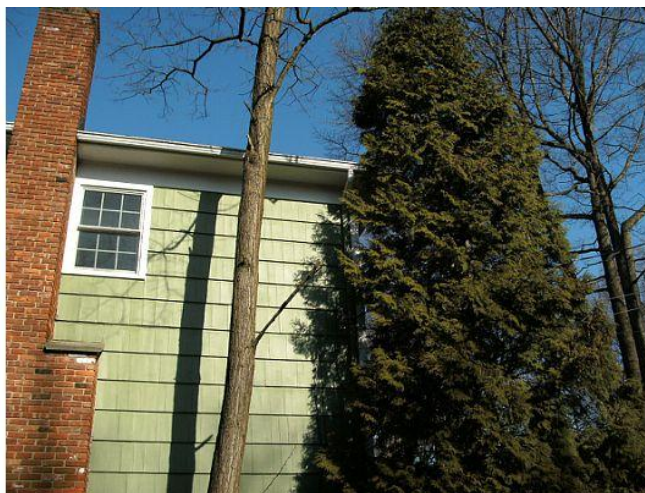
- **Overgrown vegetation in close to or in contact with the sides of the house.**
- **Trees or tree branches adversely impacting the home on multiple corners.**

Trees in contact with the home

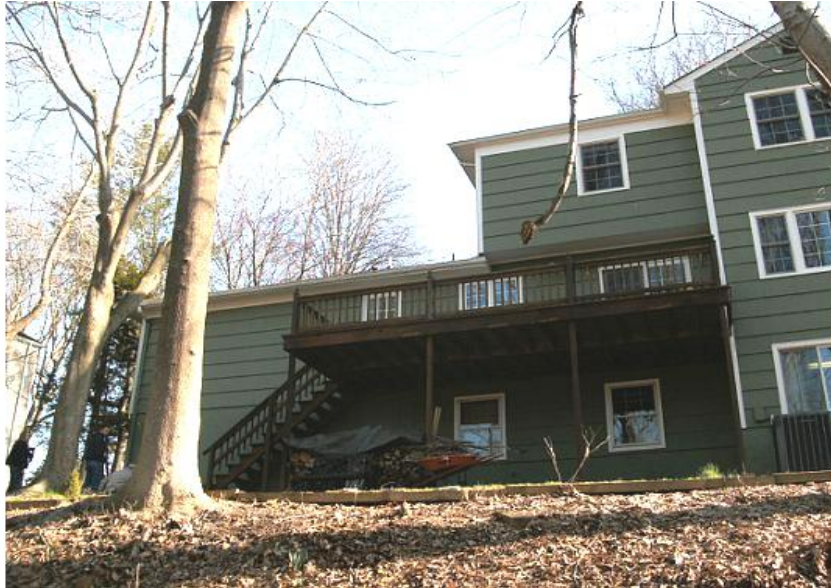
- **This home is set on a steeply sloped, wooded lot. Soil erosion and settlement**

in the future is therefore more likely to occur.

View for the home from down the slope at the rear

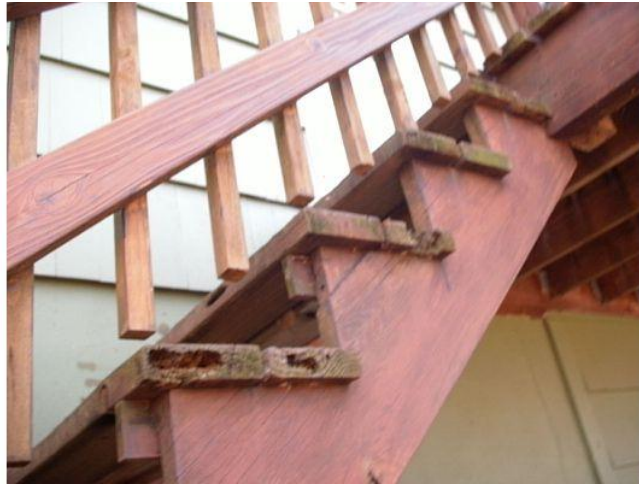
Stairs Condition: **Significant wear, loose treads, and edge rot are present along the steps.**

Deteriorated stair edges

- **The deck has sufficient wear, structural and safety deficiency to warrant complete deck reconstruction at this time. Have the deck rebuilt / replaced by a qualified contractor familiar with modern deck construction standards.**

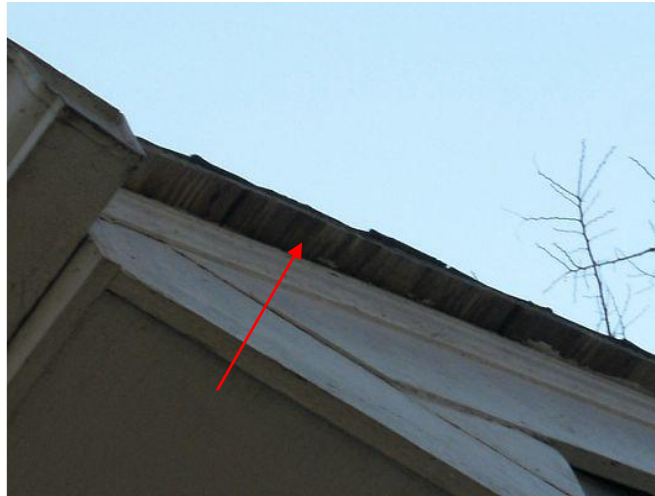
- **Some sections of wood trim have water / weather related deterioration.**
- **Exposed plywood roof decking is present in some areas at roof edges, and this plywood has sustained significant weather related deterioration.**

Exposed plywood roof decking

- **Exposed, unpainted plywood sheathing edges are visible at roof edges. This is incorrect installation and allows rapid deterioration of roof edge sheathing.**

- **Have deteriorated sections of wood trim repaired / replaced, and repainted.**
- **See Roof section for more information.**

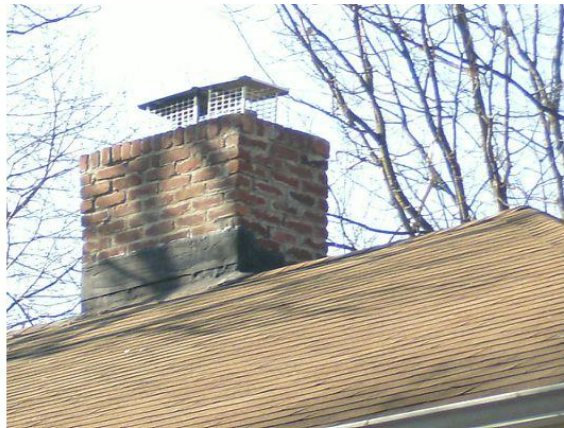
- **Chimney flashings appear to be older. Leakage is more likely to occur around older chimney flashings.**
- **Some cracks, loose and missing sections of mortar were seen on the upper sections of the chimneys. Lack of maintenance to the exterior and exterior damage strongly suggests the presence of interior hidden defects.**

The central chimney

- **The chimneys are now aging, and the possibility of interior flue blockage or other interior damage is increased.**

- **The National Fire Protection Association and the National Chimney Sweep Guild recommend that, due to the advanced age or other conditions, a Level-2 Inspection of the chimney and internal components be done to rule out hidden potential safety defects, and we recommend this as well.**
- **Have a qualified chimney contractor service or repair the chimney(s) as required to assure long term function and safety.**

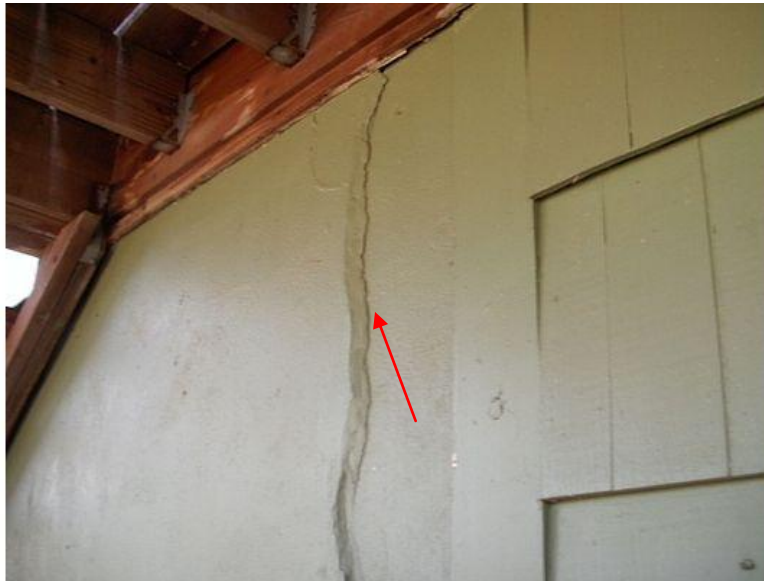
- **The foundation wall at the rear of the garage is cracked and tilting outward (downhill). The wall is being forced outward gradually by pressure from the fill below the garage. Water accumulation around the home could have contributed to this pressure. Unless adequate reinforcement or reconstruction of the rear masonry wall is done, the movement and defect in this masonry support wall will likely continue over time, and could lead to additional damage to the superstructure of the home and/or eventual wall collapse.**

Rear masonry foundation wall cracked displaced and no longer plumb

- **The defects found to be present at the rear foundation wall, together with the fact that some intermediate columns are not plumb and also the “racked” condition of the main beam strongly suggest that the support foundation walls of the home are not adequate to resist the constant heavy lateral loading of the soil at the front uphill side of the property. The finding that the front finish panel wall is not plumb also suggests that the front foundation wall has deflected inward and is “pushing” the framing out of plumb. Although the degree of the defects does not appear to be serious enough to allow collapse at this time, it is probable that going forward into the future further movement of the foundation and framing will continue to occur, and this may result in eventual structural collapse. For this reason we strongly recommend that the foundation walls and framing of this home be further evaluated for adequacy by a qualified engineer, with repair, reinforcement and/or reconstruction done as may be found to be needed to assure long term structural adequacy and stability.**

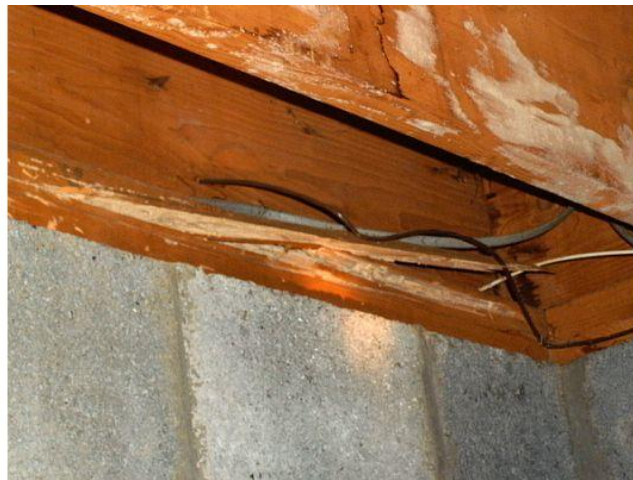
- **The sill plate at the right front corner of the basement, between the house and garage, has been damaged by a Termite infestation.**

Termite damage to the sill plate

- **See the separate wood destroying insect report from Terminite, Inc. for more information relating to the wood framing of this home. Since evidence of wood destroying insect infestation was found, then be aware that further evaluation would be required to assure that additional hidden damage to structural members is not present.**

- **Further evaluation of termite and any carpenter ant damage, with repairs as required, by a qualified contractor familiar with wood destroying insect damage repair.**

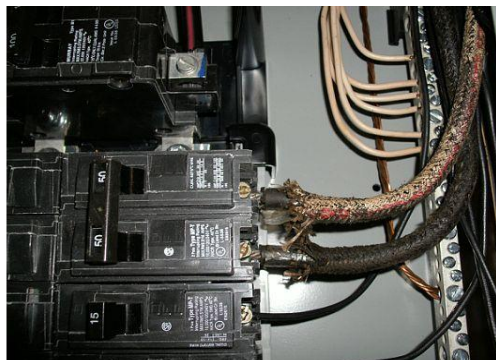
- **Total current capacity is inadequate.**
- **There is a 50 amp breaker for the central AC system, however the AC system appears to be rated for 40 amperes. This breaker therefore will not adequately protect the AC equipment and cables to the equipment. This could result in damage to cables and AC equipment, as well as fires.**

50 amp breaker for AC system may be incorrect

- **Have a licensed electrician upgrade electric service to 200 amperes capacity, replacing the main breaker panel in the process.**
- **Have a licensed electrician further evaluate the breaker rating for the central AC components, and replace with an appropriately rated breaker.**
- **Have a licensed electrician install functional GFCI electrical receptacles in all wet areas of the home including kitchens and bathrooms that lack them.**
