April 10, 2009

HOME INSPECTION REPORT

Street Address Removed

Livingston, NJ

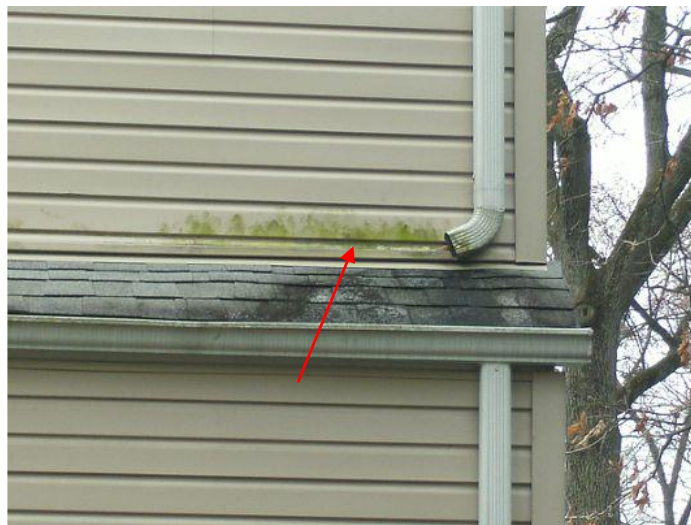
Front, Type: Stone face and vinyl siding. Condition: Functional.
Rear, Type: Vinyl siding. Condition: Functional, **however there is staining at the left rear due to algae or mildew growth, however this staining is a cosmetic issue at this time.**

- **See Roof Drainage System section for more information regarding the cause of the stains of the siding. Modify or repair roof drainage system and have the stained area of siding cleaned.**

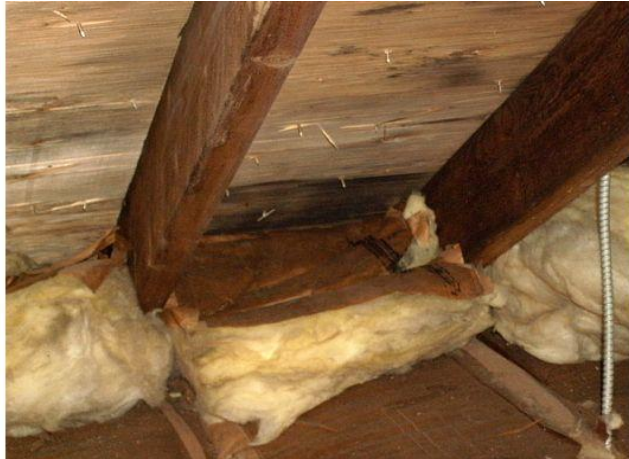
- Roof shingles appeared to be serviceable on the date of inspection.
- **Significant stained areas suggesting prior leaks or moisture condensation**

were seen on the underside of the roof in the attic crawlspaces.

Stained area of roof sheathing due to moisture condensation or leaks

- **Have a qualified roofer add more ventilation to this roof, such as larger end vents and additional field vents.**
- **Have a qualified roofer further evaluate the roof for wear and/or leakage, with repairs and replacements as necessary to ensure a long term leak free condition.**
- **See Insulation section – have insulation pulled away from roof edges.**
- **See Attic section – have a qualified roofer direct bathroom vent fan discharge through an appropriate roof stack. Bathroom vent fans should not discharge moist air directly into the attic.**

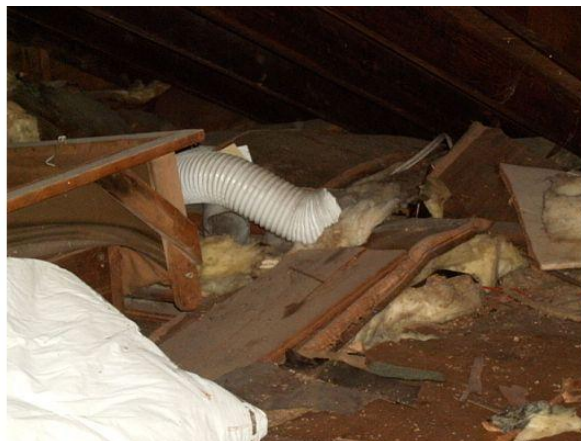
A bathroom vent fan discharges directly into the attic, which is causing significant additional moisture buildup in the attic.

Bathroom vent fan discharges into attic

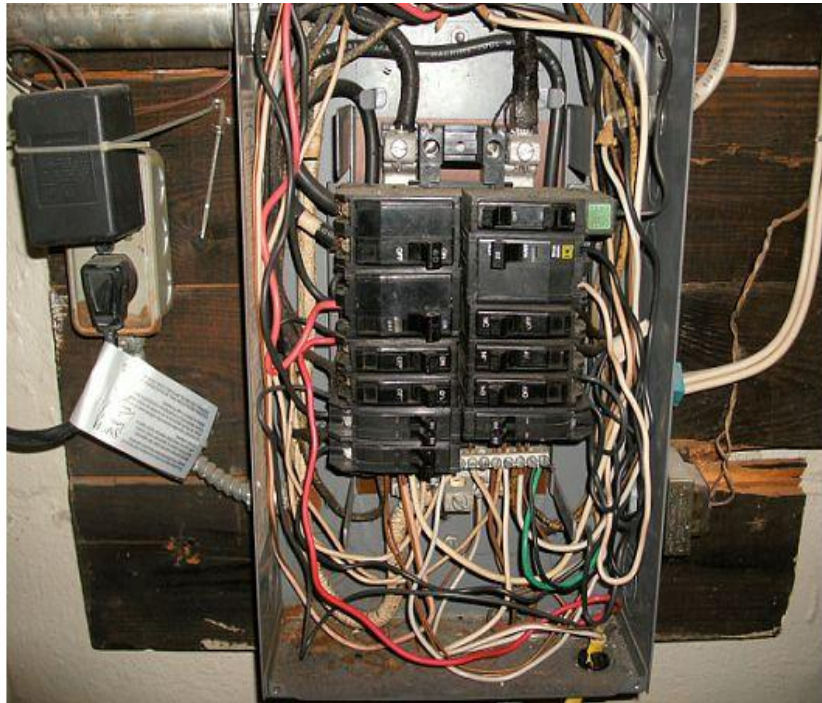
- **This breaker panel is a smaller older type panel and lacks a single main**

disconnect breaker. A single main disconnect is required for panels that have more than six separate branch circuits.

Obsolete breaker panel without single main breaker

- **Have a licensed electrician replace the existing service breaker panel with a new approved panel with a single main breaker, and upgrade total service capacity to 200 amperes along with the breaker panel replacement.**
- **Have a licensed electrician install functional GFCI electrical receptacles in all wet areas of the home including kitchens and bathrooms that lack them.**
- **Have a licensed electrician ensure that all electrical cables are properly installed and adequately secured and all electrical junction boxes and connections adequately covered / enclosed to eliminate safety hazards.**

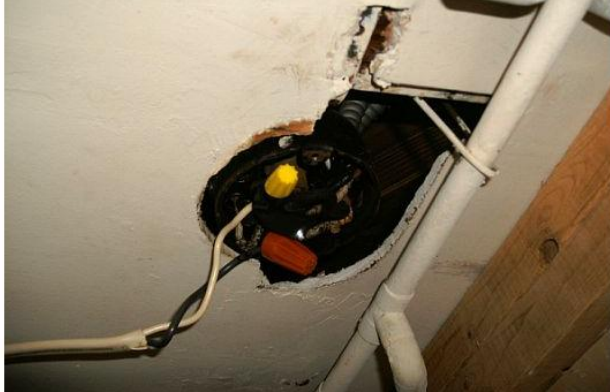
- **Some open electrical junction boxes / exposed electrical connections are present. This can be a hazard.**
- **Some improperly installed and poorly secured cables and recessed lights are present above drop ceiling panels in the basement, as well as in the garage.**

This is incorrect wiring technique, and is a hazard.

Open junction box and loose cable above drop ceiling are a hazard

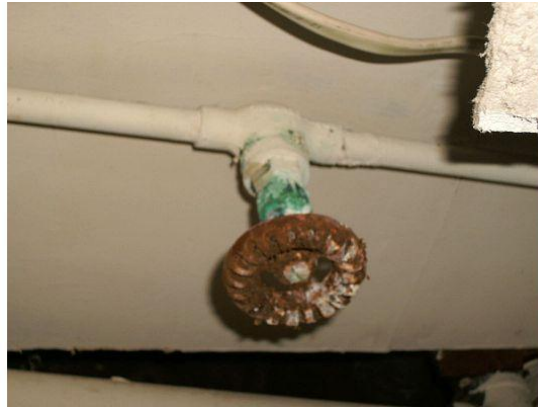
- Water pipe itself is functional.
- **Some older shutoff valves have significant corrosion and signs of leakage.**

Corroded shutoff valve suggests leakage

- **Have a plumber evaluate the main water shutoff valve and repair or replace it as necessary to assure reliable function.**
- **Have a plumber replace or repair the water supply shutoff valves with corrosion or leakage.**
- **To determine the true condition of the waste and drain pipes we recommend that a plumber inspect them internally using a specialized video camera.**

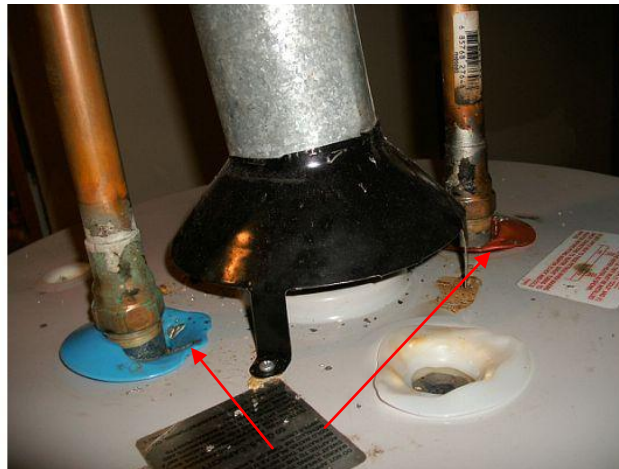
- **Although the hot water heater is only 1 year old, plastic trim rings around inlet and outlet pipes are badly melted. This could be due in part to an incorrectly installed flue pipe (see below) and/or to installation error. Back drafting of the hot flue gasses from the water heater may be a problem under certain conditions, and this is a potential hazard. It is also possible that this hot water heater will have a shortened service life as a result of this incorrect installation.**

Melted trim rings indicate problem or hazard

- **Have a qualified contractor further evaluate the hot water heater, and repair or replace as necessary to ensure a long term safe and reliable safe condition. The flue pipe must slope continuously up towards the chimney connection.**

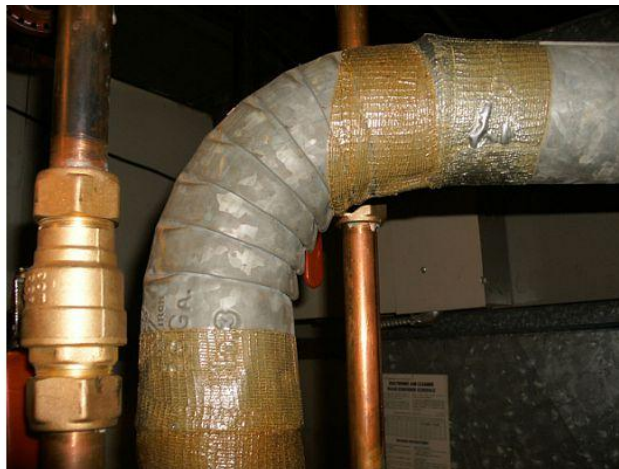
- **The hot water heater flue pipe is very old, and is incorrectly installed. The flue pipe slopes downward for part of its run towards the chimney connection. This could result in back drafting, which can allow toxic combustion gases into the home, and can damage the hot water heater.**

Old hot water flue pipe improperly installed

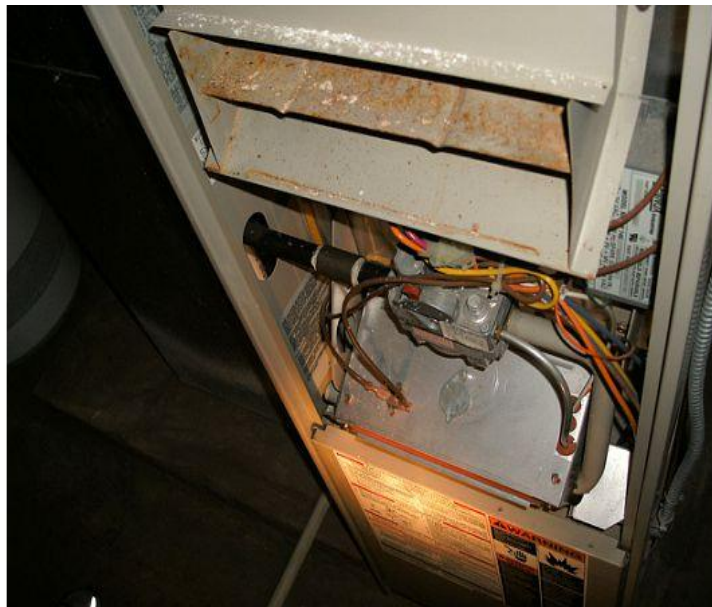
- **The heating components are more than 50% through designed service life, the possibility of hidden internal defects that can affect function and safety is increased.**
- **Visible corrosion present, which suggests hidden defects.**

The furnace interior – Aging with corrosion

- **Further evaluation of the heating system components by a qualified specialist to assure that hidden defects or safety related issues are not present.**
- **Have a qualified chimney contractor modify the flue pipe so that it slopes continuously upward towards its connection to the chimney flue. Confirmation of adequate venting of this furnace should be done after this work is performed.**
- **A service contract to cover future maintenance and repairs to the current heating system if it is found to be in safe and serviceable condition by the**

- further evaluation we recommend.**
- **Budget for the need for near term replacement of the aging heating system currently in service.**
