April 7, 2009

HOME INSPECTION REPORT
Street Address REMOVED
Millburn, NJ

The following are the findings of a **Home Inspection** of the subject property done on April 3, 2009. This report is for the use of Client name removed.

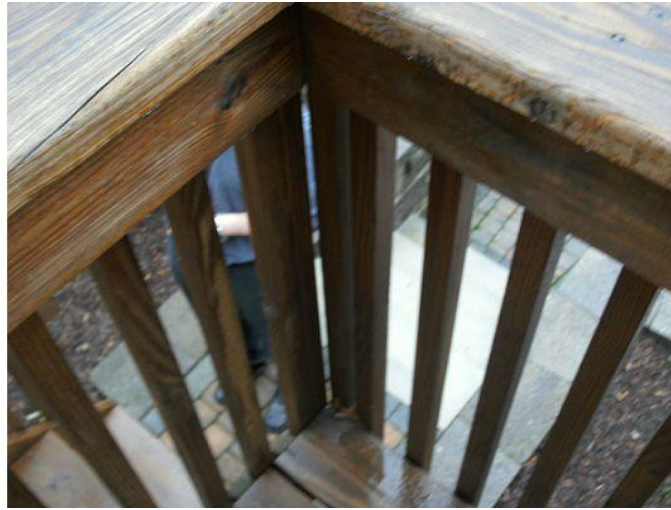
Type: Wood
Location: Rear
Elevation above grade level (approximate): 4 ft.
Structure Condition: Functional.
Surface Condition: Some wear, but currently functional.
Railing Condition: **The railing has no corner posts, only doubled up balusters.**

This is a less secure method of railing construction.

Doubled balusters instead of corner railing posts

- **Have a qualified contractor familiar with modern deck construction requirements further evaluate the railing, and reinforce as necessary to ensure a long term safe condition.**

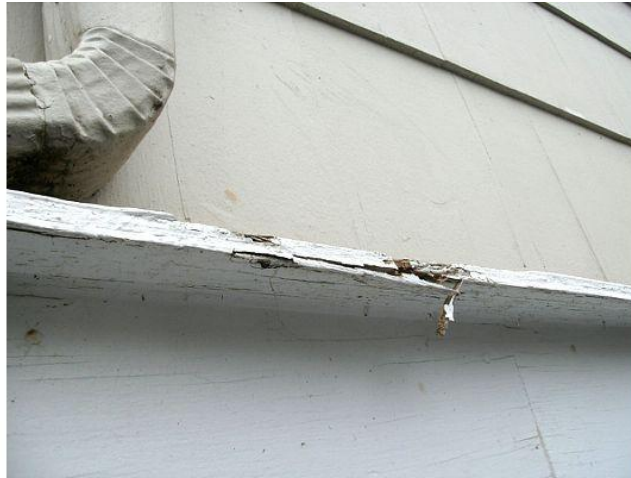
- Functional in most areas.
- **Some wood trim at the right rear corner is soft and water damaged.**

Water damaged exterior wood trim

- **Have a qualified contractor repair / replace water damaged wood trim as necessary.**

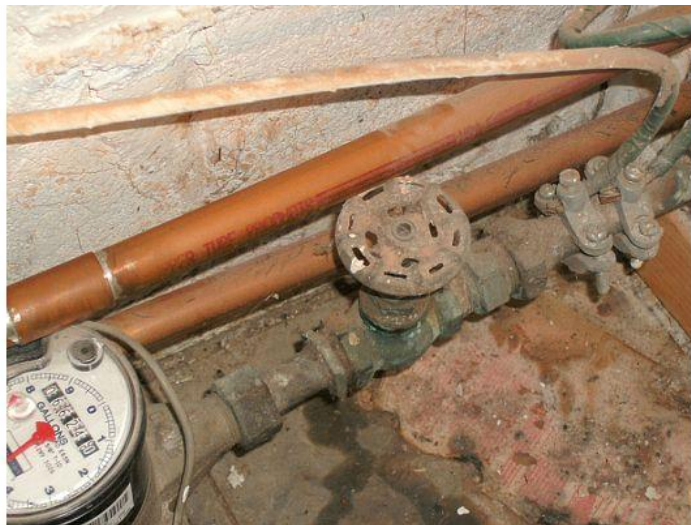
Main Shutoff Valve Condition: **The main water shutoff valve is older. Leakage can occur from older shutoff valves.**

Older shutoff valve

- **Have a plumber evaluate the main water shutoff valve and repair or replace**

- it as necessary to assure reliable function.
- **Have a plumber replace the sections of brass water pipe that are leaking as soon as possible. We also recommend that *all* remaining sections of old brass pipe be replaced, whether currently leaking or not to avoid further damage from water pipe leaks in the near future.**
 - **Have a plumber replace any older water supply shutoff valves with corrosion or leakage.**
 - **To determine the true condition of the waste and drain pipes we recommend that a plumber inspect them internally using a specialized video camera.**

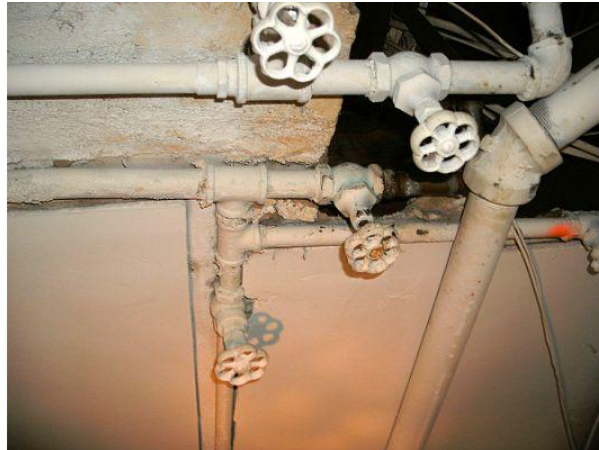
- **Old brass pipe was seen in unfinished areas of the basement and in the garage. Brass water pipe is now past the end of its designed service life, and could leak or otherwise fail without warning.**

Old brass water pipe

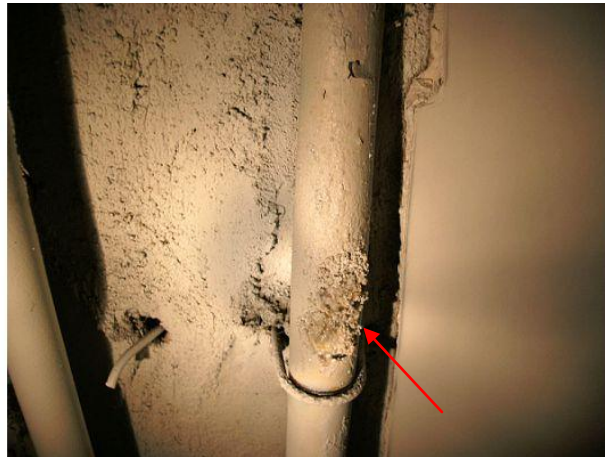
- **Some sections of brass pipe in the garage are leaking.**

Leaking brass water pipe found in garage

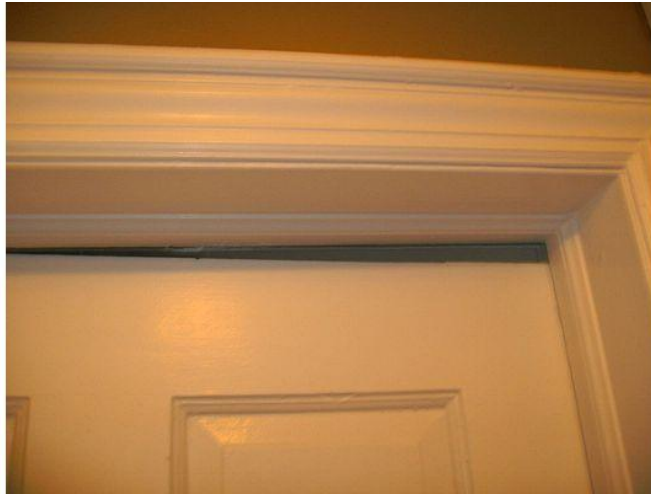
- **Some door frames on the second floor are significantly out of square, indicating structural wall and floor settlement over time.**

- Most doors were in generally functional condition.
- **As described in the Structural Supports section, the master bedroom door frame is out of alignment. The door has been cut to fit, but it has been poorly cut, and there is a significant gap visible at the top of the door frame when the door is closed.**

Gap at top of door

- **Have the master bedroom door modified or replaced to eliminate the gap.**

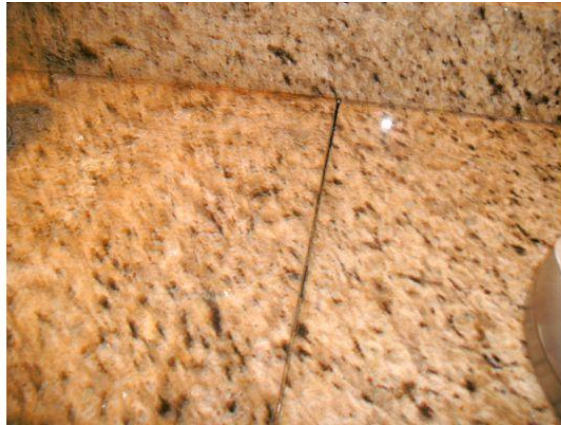
Kitchen cabinets and countertops are in functional condition, **with the exception of a significant gap between two counter top sections. Gaps in counter tops can result in unsanitary conditions.**

Counter top gap

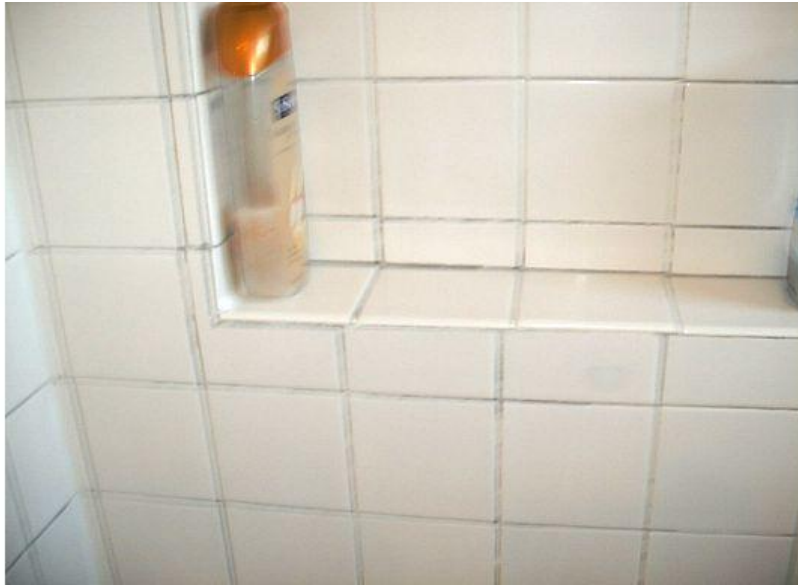
- **The cold water sink faucet in the second floor main bathroom is stiff, and is incorrectly installed. Turning the faucet clockwise turns the faucet on, and counterclockwise off (opposite of the way it should be).**
- **There is a tile shelf area in the master bathroom stall shower, which is vulnerable to leakage.**

Tile shelf area

- **Have a plumber repair the main bathroom sink faucet and loose third floor bathroom tub spout.**
- **Monitor the tile shelf area in the master bathroom shower area for any signs of loose tile, and have repairs made promptly as necessary. You may wish to have a solid surface material such as marble or granite installed on the shelf area, to better prevent water entry.**

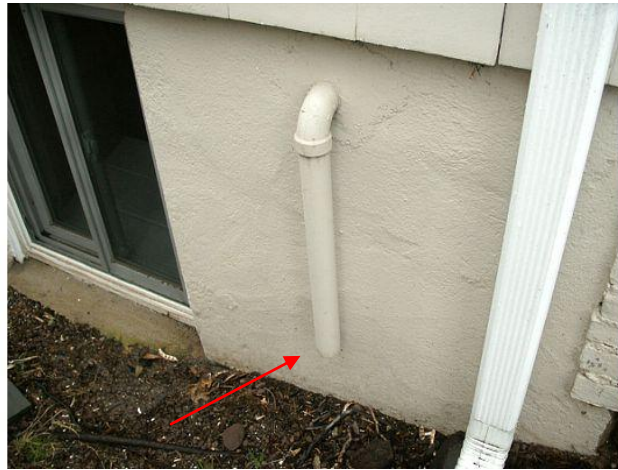
- The sump was dry on the date of inspection.
- The pump was tested by lifting the float, and appeared to be functional on the date of inspection.
- **The sump pump discharge pipe exits directly at the base of the home. This will allow discharged water to flow back towards the home.**

Sump pump discharge pipe discharges at the base of the home

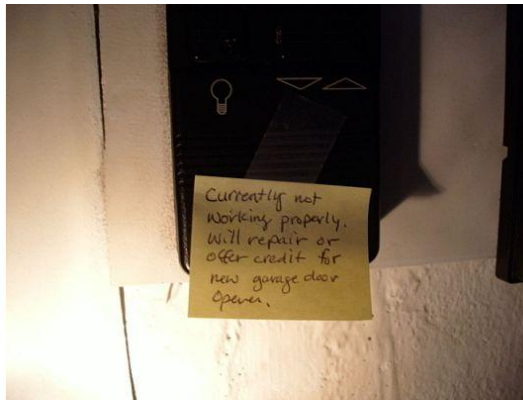
The right side door was operated and was found to be functional. **The left side door was not functional on the date of inspection.**

Note on opener indicating it does not work (placed by seller)

Power Opener safety cutoff sensors: Present on both openers. Right side tested operational by interrupting beam. **Left side opener could not be tested.**

- **Have the non-functional garage door / opener repaired and tested operational prior to closing.**
