May 17, 2008

HOME INSPECTION REPORT
Street Address Removed
Morristown, NJ

The following are the findings of a **Home Inspection** of the subject property done on May 14, 2008. This report is for the use of Client name removed.

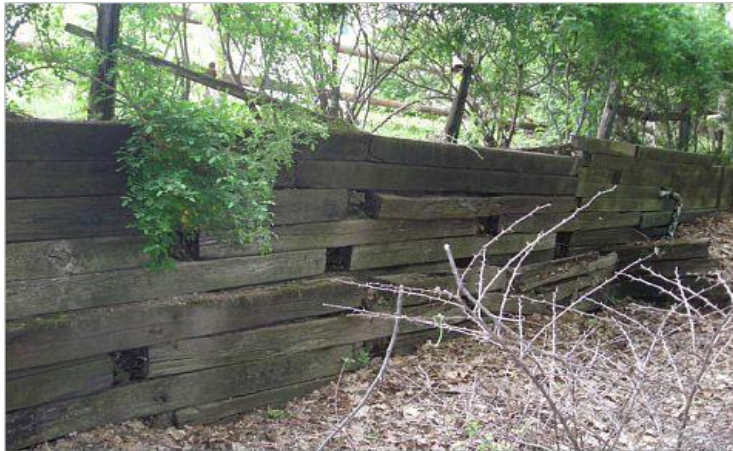
The retaining wall at the rear of the back yard is in poor condition, and has essentially failed. Most areas of wood are badly rotted or insect damaged. Sections of the wall are tilted far out of true. This wall will continue to deteriorate, and collapse. This could lead to soil subsidence at the rear of the back yard, and eventual damage to the home.

Wood rear retaining wall has failed

- **Install a new retaining wall at the rear of the yard. This work should be done by a qualified mason and/or landscaper. Suggest using interlocking concrete block, stone that will be less vulnerable to water and insect deterioration than the current wood tie wall material.**

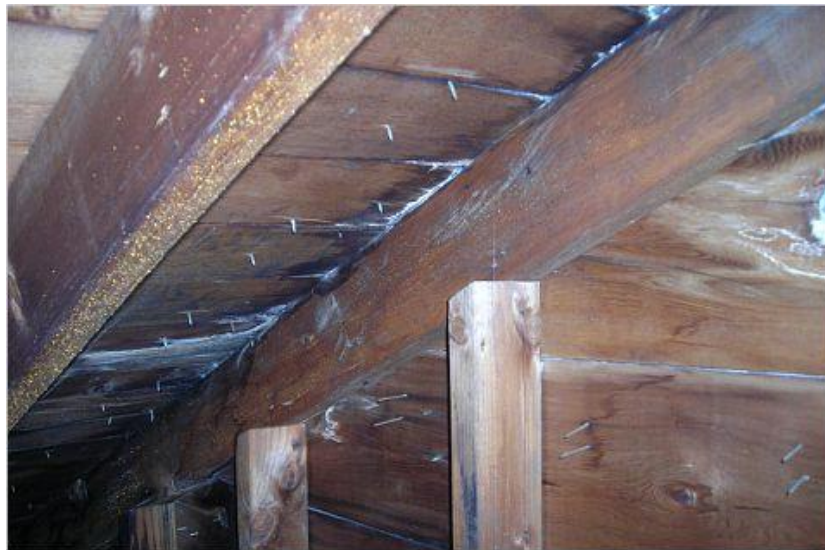
- **Roof shingles appeared to have moderate wear.**
- **Stained areas suggesting current leakage and moisture condensation are present on the underside of the roof in the attic crawlspaces. These stained areas were most pronounced at the left front of the attic, around the chimney.**
- **The stained areas tested wet with a moisture meter. The roof is definitely leaking in this area, and may be leaking in other areas as well.**

Stained areas in attic indicate roof leakage

- **Leakage may be related to incorrectly installed chimney flashings (see Chimney section).**
- **Live carpenter ant activity was found in the attic around the stained areas at the edge. Carpenter ants may be causing damage to the roof sheathing.**

- **The roof is currently leaking, apparently around the chimney. Have a qualified roofer repair or replace roofing materials and chimney flashings as necessary to assure leak free service.**
- **Have a qualified contractor modify or install soffit vents to increase attic ventilation under the roof.**

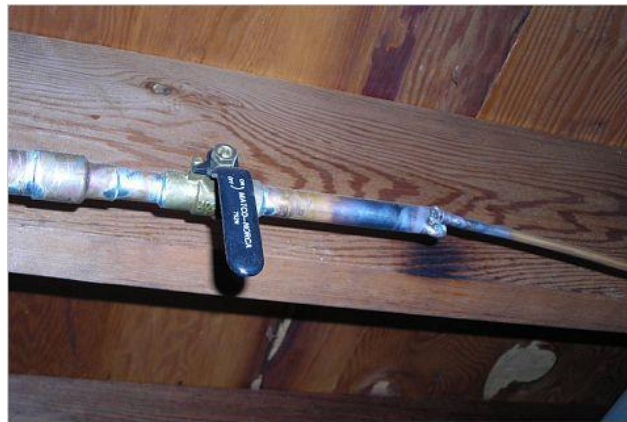
- **Some older and corroded water supply shutoff valves and connections are present.**
- **A poorly crimped and brazed connection from a larger water pipe to a smaller pipe is present.**

Poorly done connection

- **Have a plumber evaluate the main water shutoff valve and repair or replace it as necessary to assure reliable function.**
- **Have a plumber replace any older water supply shutoff valves with corrosion or leakage, and repair any corroded or poorly done water pipe connections.**
- **To determine the true condition of the waste and drain pipes we recommend that a plumber inspect them internally using a specialized video camera.**

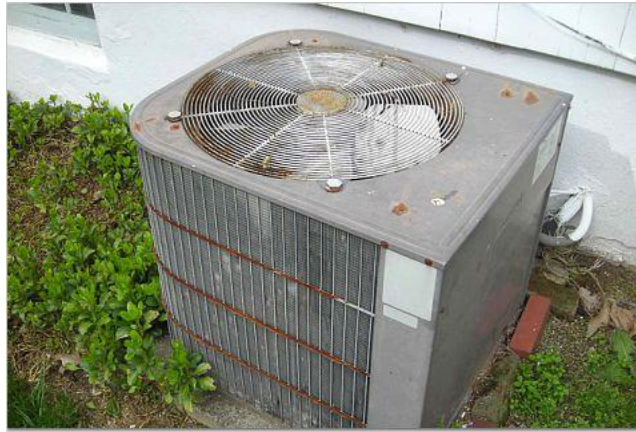
- **The AC components are now well past the end of their designed service life. Continued reliable operation cannot be assured.**
- **Significant corrosion is present on the AC equipment.**

Aging AC equipment with corrosion

- **Have the AC components replaced along with heating system replacement.**
- **A service contract to cover future maintenance and repairs to the AC system.**

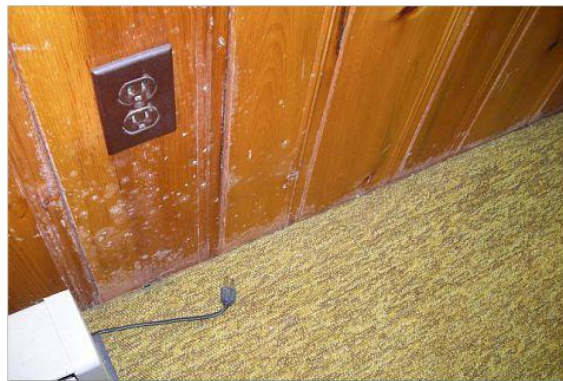
- **Most areas of paint or finish surface are worn.**
- **Wood paneling at the right rear has spotted areas near the floor, suggesting the possibility of moisture entry and possible mold growth behind paneling (see Basement and Mold sections).**
- **Walls in the garage show evidence of termite activity.**

Spotting from mold growth on wood panels

- **General interior repainting and refinishing by a professional painter.**
- **See Basement and Mold and Wood destroying insect report sections.**
- **Refinishing of wood surfaces and replacement of other floor surfaces as desired.**
