April 19, 2008

## HOME INSPECTION REPORT

### XXXXDrive

Mountainside, NJ

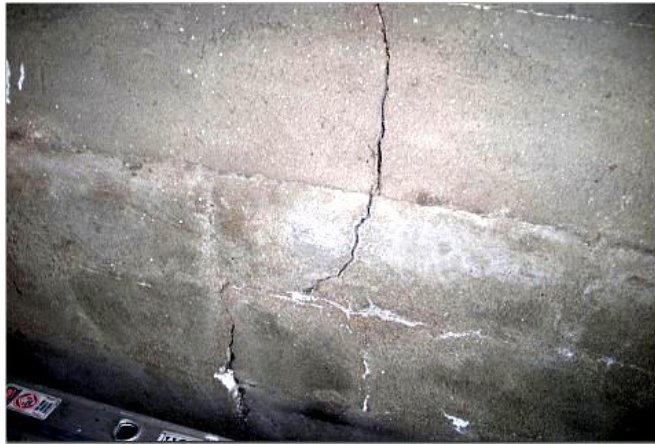
- After construction of a home over the course of time it is common for a small amount of soil compression to occur under the foundation wall footings, and this may result in cracks that are approximately vertical, diagonal or stair-step in pattern. Cracks of this type that are less than 3/16 inch wide with no other complicating factors are not considered to be structural defects in need of repair. **Our home inspection found foundation wall cracks of the type and degree described above, along the right side of the garage wall.**

Crack in garage wall, on right side

- **See Roof Drainage section – make sure water around the home is well controlled, with no accumulation near the base of the home. This can help reduce the possibility of foundation settlement in the future.**
- **The visible areas of vertical cracks found appear to be relatively minor and do not appear to significantly affect functionality of the foundation. Other than sealing the crack to prevent water and insect entry, no repair is recommended at this time. We do recommend, however, that the foundation walls be monitored over time for additional cracks or expansion of the existing cracks, and if this occurs, then further specialist evaluation followed by structural repairs may be needed.**

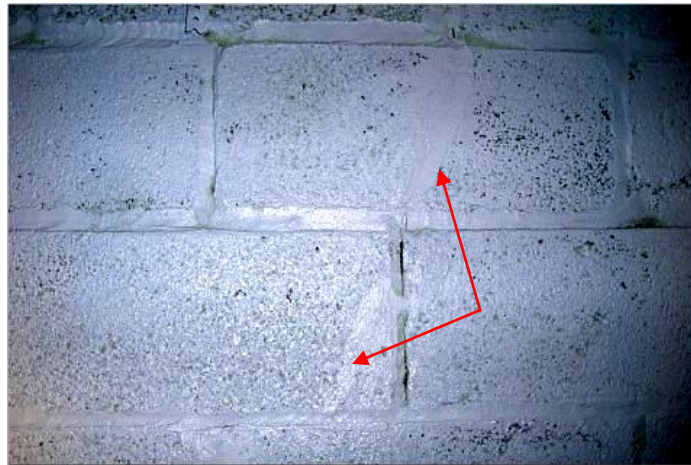
- **Some areas of *patched* cracks appear to also be present in the basement. *The patching and paint on basement walls limits our evaluation of the severity of these cracks.***

Patched cracks on foundation wall visible in basement

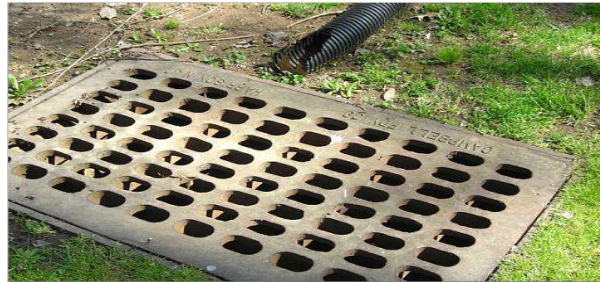
- **This home is located in a low area which may be prone to seasonal flooding. The back yard is flat, however there appears to be a dry stream bed to the rear of the property.**
- **A drainage grate is present on the right side of the property, in the back yard.**

Drainage grate in back yard

- **Monitor water conditions in the back yard for areas of water accumulation.**
- **Keep existing drainage grates clear and free flowing.**
- **Have a landscaper raise the paths at the right side and rear, and slope paths away from the home to defend against water accumulation at the base of the home.**
- **If water accumulation occurs on the property during heavy rains, the addition of more drainage and water diversion methods may become necessary.**

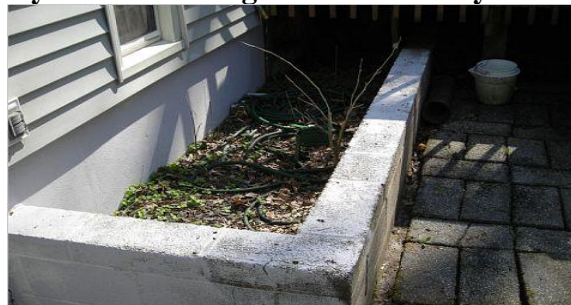
- **A low concrete block wall has been constructed around a rear basement window, possibly as a defense against water entry.**

Low wall surrounds part of the rear, including basement window under the deck

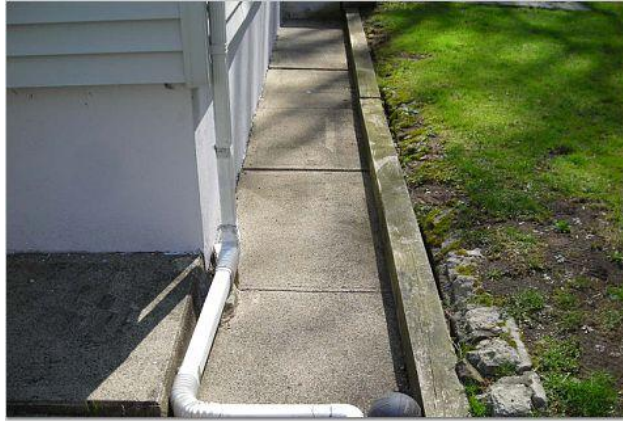
- **A portion of concrete path at the right side and rear is below the level of a low wood tie wall. Water may accumulate in this area.**

Path section lower than tie wall

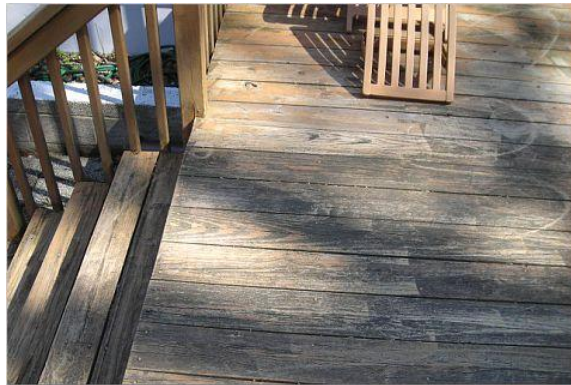
Surface Condition: **Significant deck board wear is present.**

Deck surface is worn

- **The deck is wearing, and replacement of deck surface boards or deck reconstruction will be necessary in the near future. This work should be done by a qualified contractor familiar with modern deck construction.**

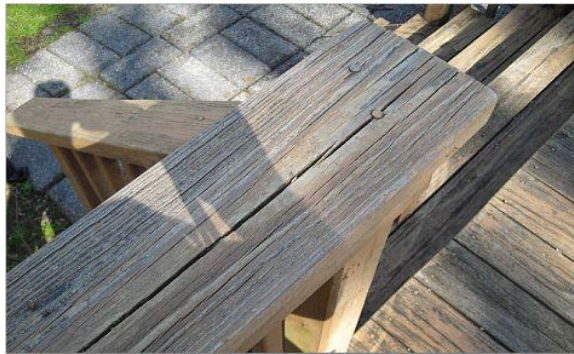
Railing Condition: The railing was tested, and found to be sound, on the date of inspection, **however the railing top board has significant wear.**

Splitting railing top board

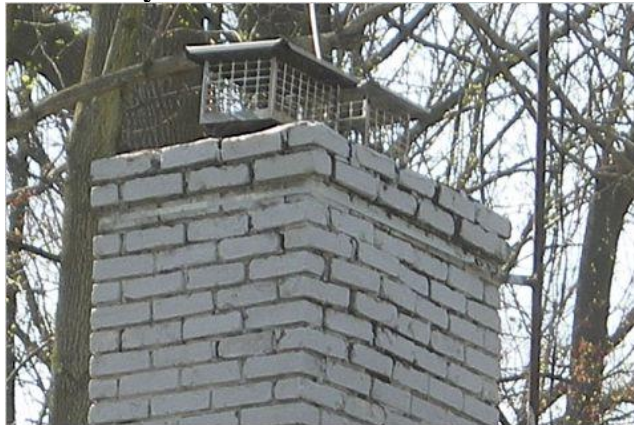
- **Chimney flashings appear to be older. Leakage can occur around older chimney flashings.**
- **Some cracks, loose and missing sections of mortar were seen on the upper sections of the chimney.**

The chimney brick is painted white, but joints still requires re-pointing

- **The National Fire Protection Association and the National Chimney Sweep Guild recommend that, due to the advanced age or other conditions, a Level-2 Inspection of the chimney and internal components be done to rule out hidden potential safety defects.**
- **Have a qualified chimney contractor service or repair the chimney as required to assure long term function and safety.**

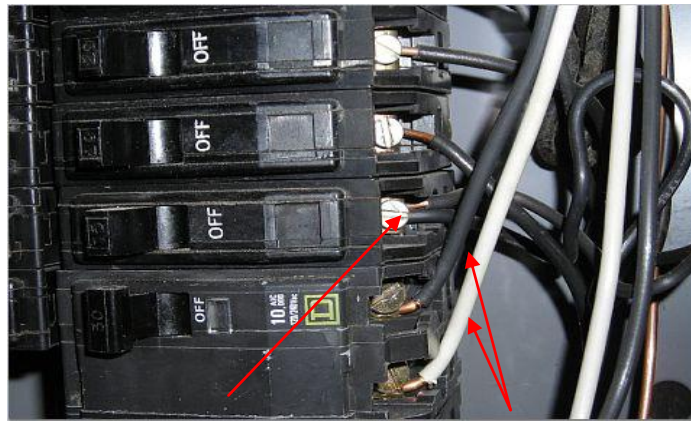
- **A double tapped circuit breaker (more than one wire connected to a circuit breaker) is present in the panel. This is incorrect wiring technique.**
- **Several wires are strained (there is insufficient slack) at their connections to circuit breakers.**

Double tapped breaker and strained wires

- **Have a licensed electrician eliminate the double tapped condition in the circuit breaker panel.**
- **Have a licensed electrician repair the strained wires in the panel.**
- **Electrical capacity upgrade to 200 amperes may be needed to adequately serve your needs, and we recommend that this upgrade in capacity be done. The previous repairs may also be accomplished in this process, as an upgrade would require service panel replacement.**

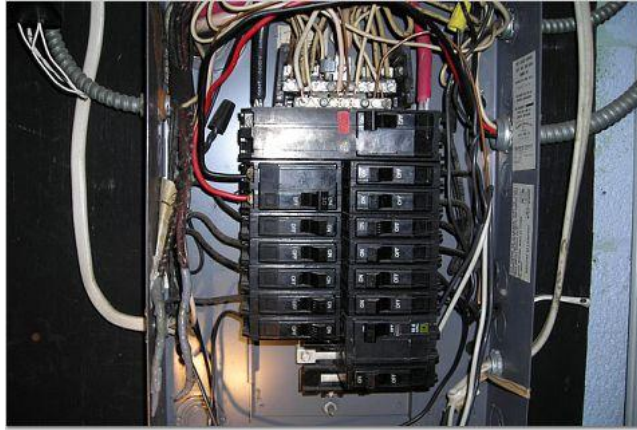
- **There are unused wires in the panel that have been taped off (see below).**

Taped off wires are present in the panel

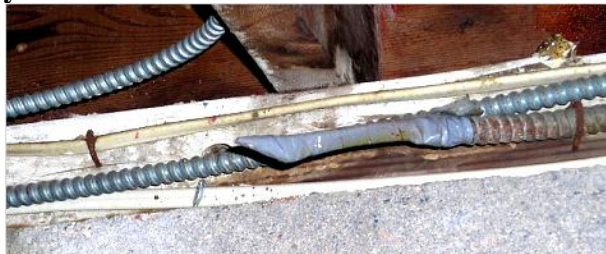
- **An unused cable is dangling at the rear of the basement. This may be the same cable that has taped ends in the circuit breaker panel, however we cannot certify that this is so.**

Taped off unused cable in basement

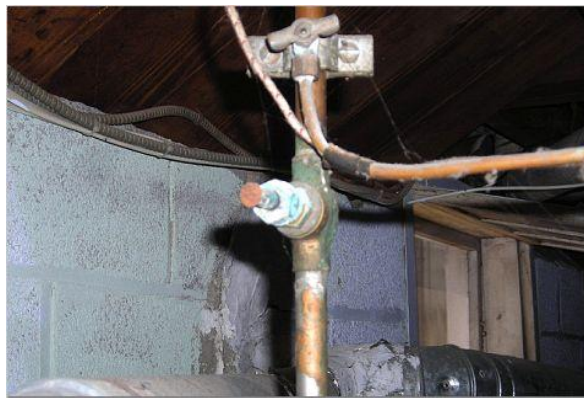
- Water pipe itself is functional.
- **Some older, corroded shutoff valves are present, including a valve near the hot water heater with a missing knob.**

Old shutoff valve with missing knob

- **Have a plumber evaluate the water main and expansion tank to determine whether adequate water pressure exists, and the purpose of the expansion tank. Have modifications made if possible to increase and/or maintain desired level of water pressure.**
- **To determine the true condition of the waste and drain pipes we recommend that a plumber inspect them internally using a specialized video camera.**

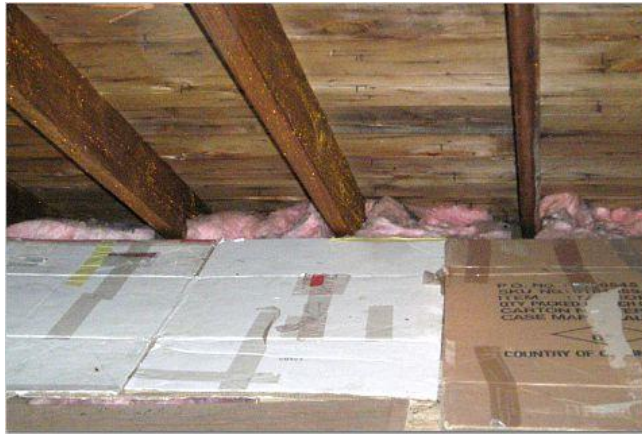
- **Insulation extends all the way to the edge of the roof, obstructing any possible soffit vents.**

Insulation pushed to the roof edge

- **Have a qualified roofer add more ventilation to this roof by opening more soffit vents, and pulling back insulation from the roof edge.**
- **Have a qualified roofer periodically evaluate the roof for wear and signs of leakage, and make repairs or replacements as necessary.**

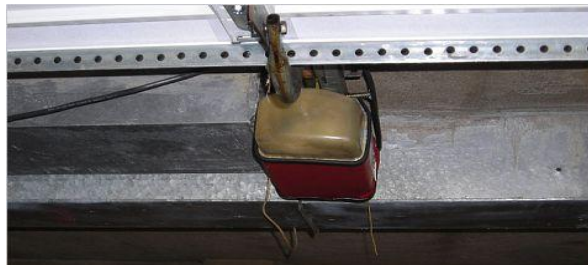
- **No safety cutoff sensors present – this type of opener is obsolete, can cause severe injury, and must be replaced.**
- **Openers are plugged in with extension cords.**

Older openers have no sensors, and are plugged in with extension cords

- **Have the garage door opener(s) lacking adequate electric eye safety cutoff sensors replaced with new openers incorporating electric eye cutoff sensors. This work should be done by a qualified garage door contractor.**
