May 25, 2009

HOME INSPECTION REPORT

Address REMOVED

Ridgewood, NJ

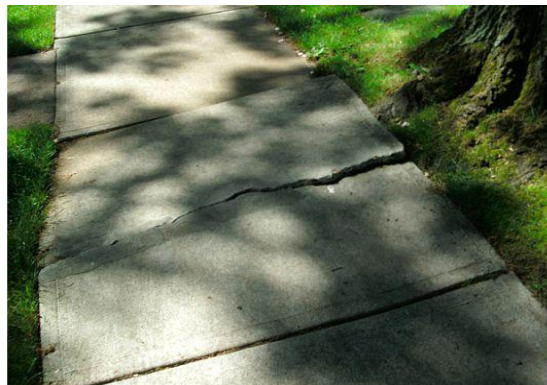
Sidewalk Condition: **A section of sidewalk has been pushed up and cracked by a tree root. This is a tripping hazard.**

Cracked sidewalk

- **Have the cracked section of sidewalk repaired or replaced.**

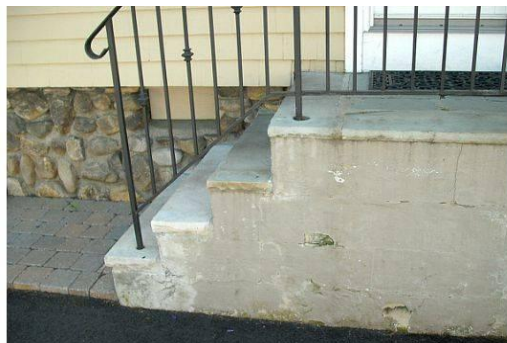
Side Entry Area: Masonry steps, functional, but **only fair condition due to moderate deterioration.**

Masonry Steps at Side are in Only Fair Condition

- **Have a qualified contractor properly repair the damaged stair support and cracked floor joist.**
- **Continued maintenance of the masonry steps to extend functional life.**

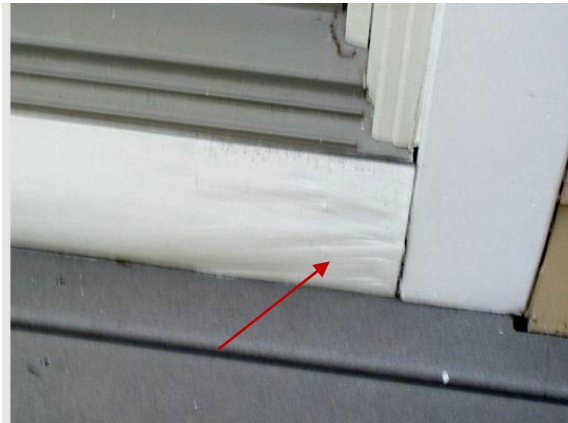
- Functional in most areas.
- **The threshold board beneath the back door is deteriorating from moisture and weather exposure.**

Deteriorating threshold board

- **Remove the damaged back entrance door threshold board, evaluate area, and replace board and make any additional repairs as may be found to be needed in this area.**

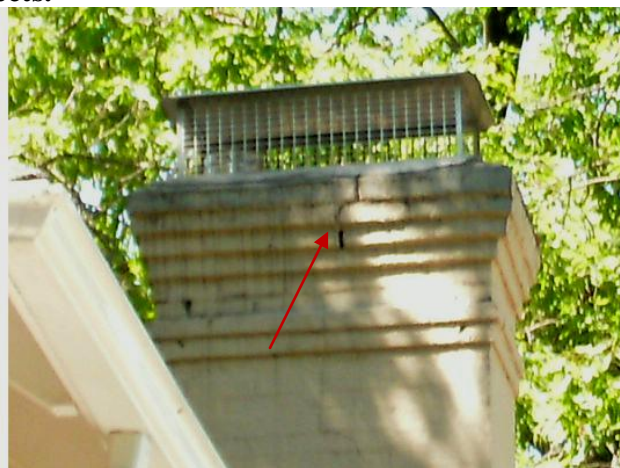
- **Some cracks, loose and missing sections of mortar were seen on the upper sections of the chimney. The exterior damage suggests the presence of interior defects.**

Cracks in the masonry chimney visible at top

- This chimney is quite old, and the possibility of interior flue blockage or other interior damage is therefore increased.

- The National Fire Protection Association and the National Chimney Sweep Guild recommend that, due to the advanced age or other conditions, a Level-2 Inspection of the chimney and internal components be done to rule out hidden potential safety defects, and we recommend this as well.
- Have a qualified chimney contractor service or repair the chimney as required to assure long term function and safety.

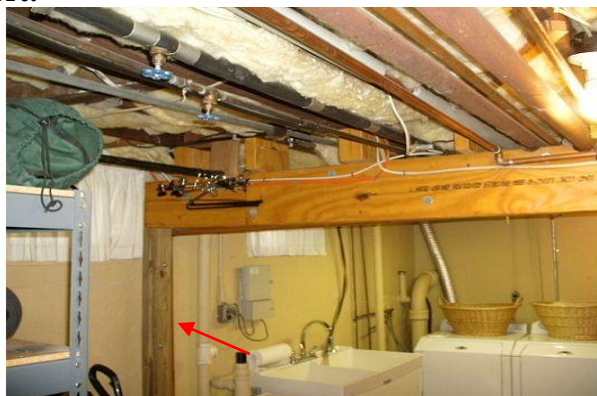
- The concrete filled steel tubular columns are in functional condition where visible.
- **The wood support post at the end of a (newer) laminated wood beam is an unorthodox installation that may not be adequate to provide long term structural support.**

This Wood Post Support May Not be Adequate

- **See Roof Drainage section – make sure water around the home is well controlled, with no accumulation near the base of the home. This can help reduce the possibility of additional foundation settlement in the future.**
- **Have a qualified contractor adequately support the end of the wood beam described previously. Suggest the installation of an additional lally column installed on a proper footing near the end of the beam, but clearing the existing steam return pipe. The existing end support post may be left in place.**
- **See the separate wood destroying insect report from Terminite, Inc. for more information relating to the wood framing of this home. If evidence of wood destroying insect infestation is found, then be aware that further evaluation would be required to assure that hidden damage to structural members is not present.**

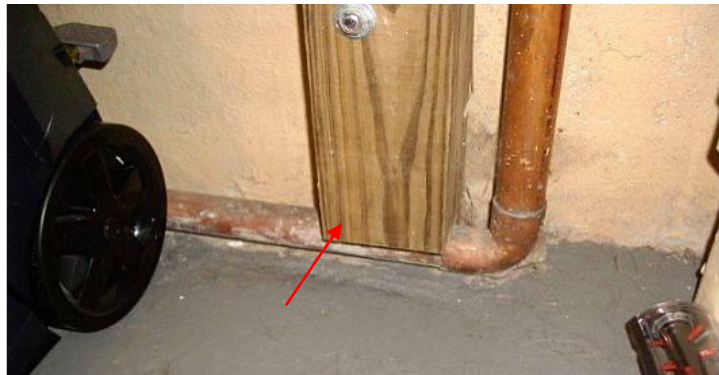
- Flooring throughout the home was adequately level and stiff for a home of this type and age on the date of inspection.
- The end of a newer laminated wood beam is supported by wood support post bolted to the masonry wall. **The bottom of this support post is not supported by a proper footing and has been partially cut away to allow for the passage of a steam return pipe. Consequently, this support may not be adequate to provide long term structural support of the beam.**

Support post notched over heating return pipe and not on footing

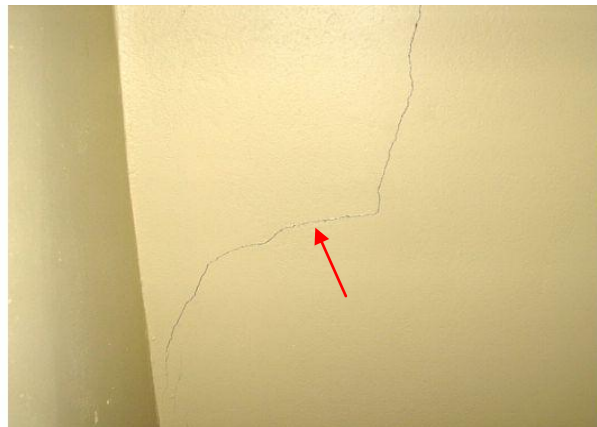
- Walls throughout the home are functionally adequate where visible in most areas.
- **The plaster is cracked on a wall adjacent to the chimney on the second floor. This is a common condition for older homes of this type, and may have been caused by differential settlement between the chimney and the main structure of the house.**

Plaster Wall cracked near chimney

- Functional, with typical cracking and defects for a home of this type and age, mostly of a minor nature.
- **Some wall cracking is present on the second floor in a bedroom, in a wall adjacent to the chimney (see Structural Supports section).**

- **See Structural Supports section.**
- **Have a qualified painter professionally repair and repaint the crack. Be aware that future differential movement between the chimney and wood framing is possible and may cause the crack to re-open.**

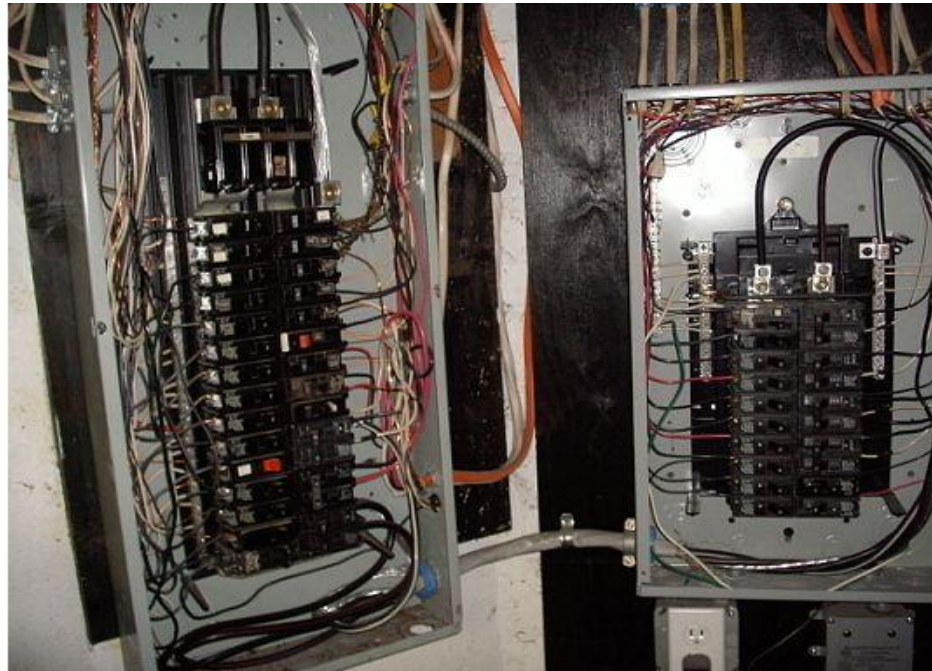
- **The main service panel is full and the subpanel installed together with the circuits in the main panel may exceed the designed load capacity for the main service.**

Main Electrical Service Panel (left) and also added Subpanel –full or possibly over capacity

- **Have a licensed electrician evaluate the electrical service panel and subpanel for adequacy of capacity and proper installation. Service upgrade to 200 amperes may be found to be advisable.**
- **Have a licensed electrician eliminate the double tapped condition in the circuit breaker panel.**
- **Have a licensed electrician evaluate the home with regard to knob & tube wiring. If found to be present, it is advisable to have such wiring disabled and/or removed, with the affected circuits replaced with approved wiring.**

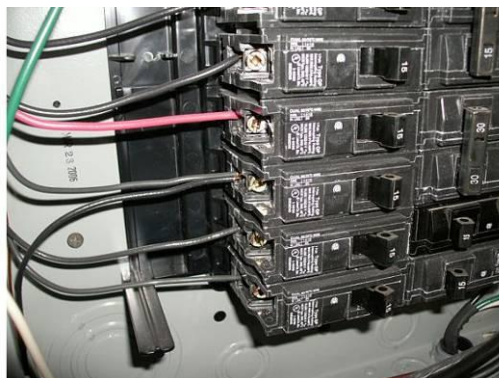
- **One double tapped circuit breaker is present in the subpanel. This is incorrect wiring technique.**

Double tapped breaker in sub panel

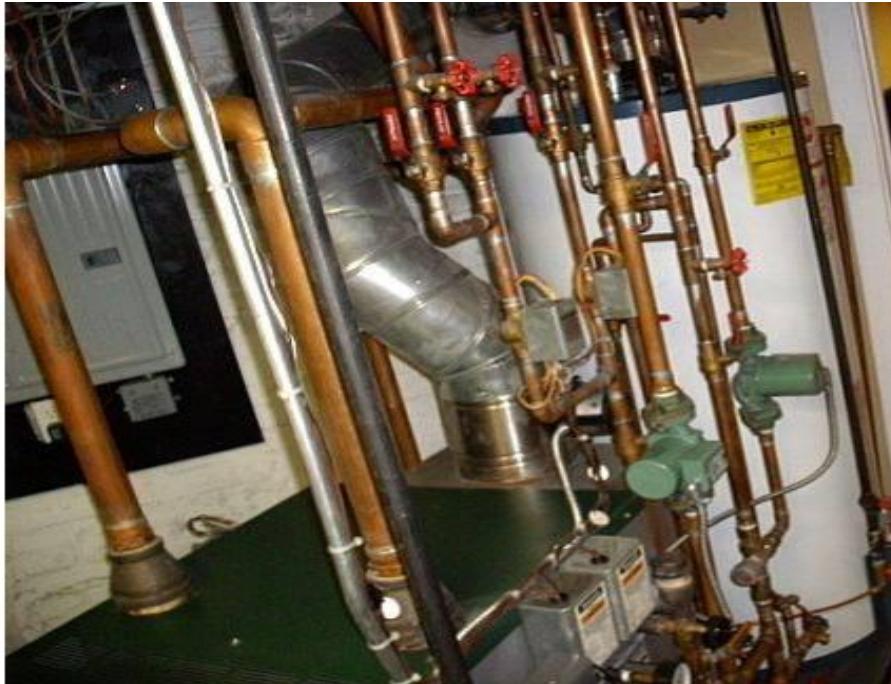
Heating System is Combination of Steam and Circulated Hot Water from Same Boiler

- **The use of the steam boiler to supply circulated hot water heating zones in addition to the steam is not an ideal arrangement. Steam boilers create considerable sediment during the normal course of operation. When circulated hot water zones are installed on steam boilers, the pumps, valves, pipes and baseboard radiators are more subject to clogging and failure than when installed on a standard hot water boiler. Consequently, this heating system may require increased maintenance and repairs during its service life, and the service life of components may be shorter than average.**

- **Some of the major steam pipes are copper rather than threaded iron pipe. Copper steam pipes are not as durable as threaded iron in steam service, and are more subject to leakage and failure at joints.**

- **Radiators and steam or circulated water pipes are older, and the need for increased maintenance and repair to these older components should be anticipated.**

- **Further evaluation of the heating system by a qualified specialist to determine if modification is needed to assure reliable service. You may wish to have the heating system modified so that all rooms are heated by circulated hot water rather than a combination of steam and hot water).**
- **Monitor radiators and radiator connections for leakage, and have any leaks repaired promptly.**
- **A service contract to cover future maintenance and repairs to the heating system.**

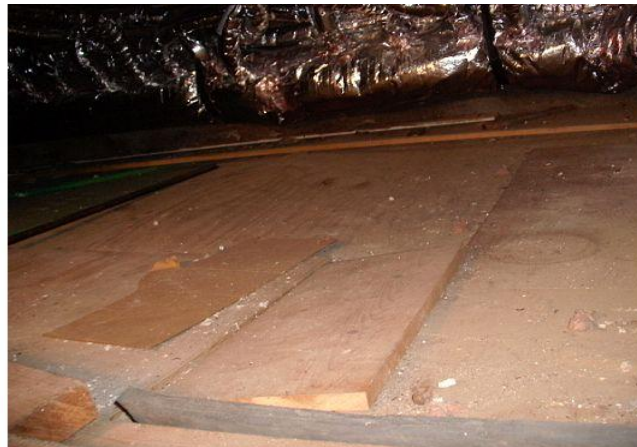
- **Signs of prior water entry were found to be present on some visible areas of foundation walls.**
- **In the rear crawlspace, the dirt floor areas are covered with thin plywood. This wood is now deteriorating from moisture exposure. Wood in contact with soil is conducive to wood destroying insect entry and mold growth.**

Wood in contact with soil on the crawlspace floor

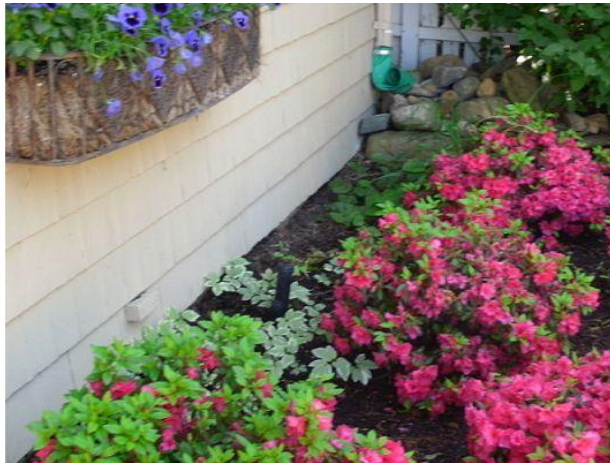
- **No button appears to be present for the garage door opener within the garage. The opener can only be operated with the exterior keypad or the garage remote. This is a potential hazard.**
- **Soil and mulch has accumulated around the garage and is now touching the garage siding. This is conducive to wood destroying insect entry.**

Mulch touching garage siding

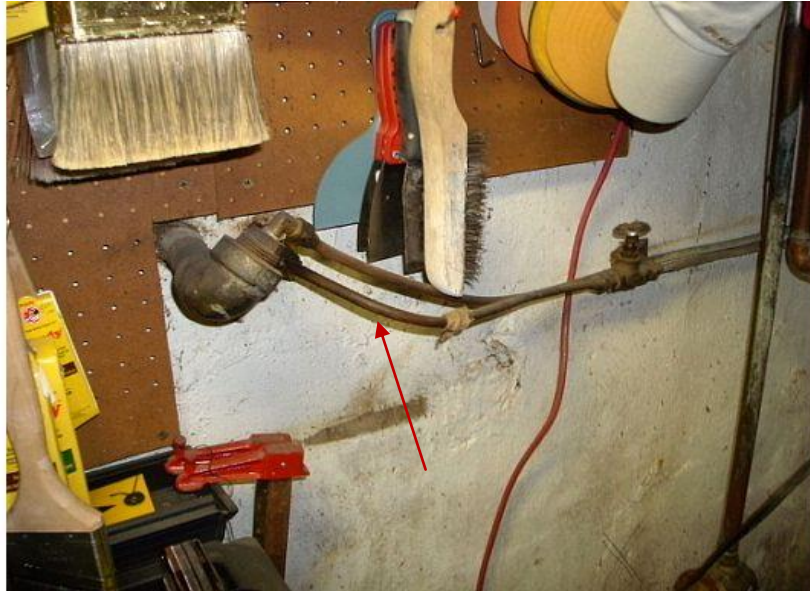
The heating system for this home uses natural gas. **Prior heating systems did appear to use oil. Evidence that an oil storage tank is present, or was present buried underground in the front.** Buried oil storage tanks corrode and become defective over

time, and may leak oil into the ground creating an environmental hazard.

Old fuel oil lines passing through wall suggest that a buried tank may be present

- **Specialist search for abandoned buried tanks and specialist evaluation of buried and/or above ground oil storage tanks, either in use or abandoned. As leaking oil tanks can result in significant expenses, we advise careful review with legal counsel of any documents or statements relating to oil tank(s).**
