May 1, 2008

HOME INSPECTION REPORT
Street Address Rmoved
Verona, NJ

MHI Services, Inc. - Licensed Home Inspectors

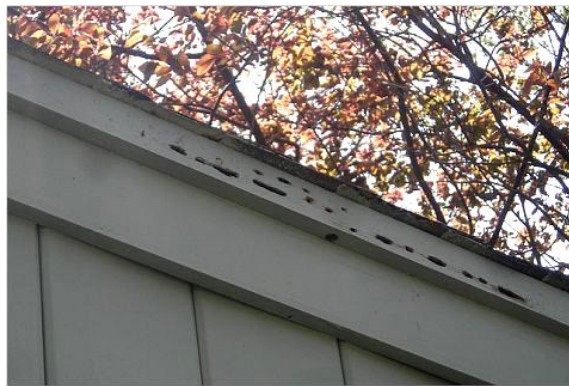
- **Some wood trim around the screened, enclosed patio is very worn, and has failed paint.**
- **Wood trim on the roof edge on the left side has been damaged by what appears to be carpenter bee activity.**

Carpenter bee damage to wood trim

- **Repair, replacement and repainting of wood trim where necessary.**
- **See the separate wood destroying insects report from Terminite, Inc.**

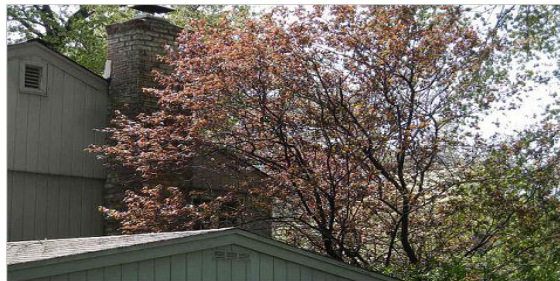
Landscaping **Small trees, shrubs and plants are very close to, overhanging, or in contact with the siding and roof edge. This is conducive to wood destroying insect damage, and could cause damage to roof and siding in heavy winds.**

Tree in contact with the home

- **Have trees, shrubs and plants trimmed back or removed so they are no longer in contact with the home.**

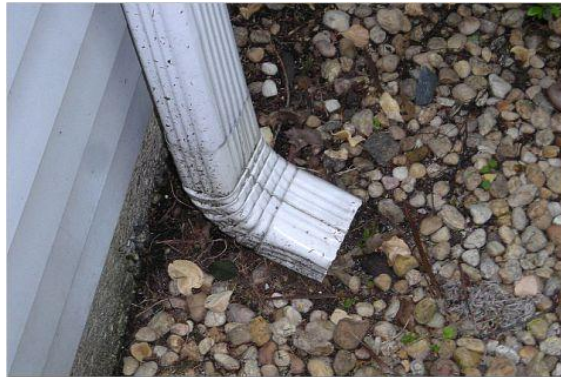
- **Some downspouts discharge very close to the base of the home.**

Downspout discharging at base of home

- **Direct all downspout discharge points as far away and downhill from the base of the home as is practical.**
- **Monitor gutter and downspout connections for overflow and/or leakage, and have modifications made as necessary by a qualified gutter maintenance company to optimize roof drainage.**
- **Have the roof drainage system cleaned and maintained on a regular basis by a qualified gutter maintenance company.**

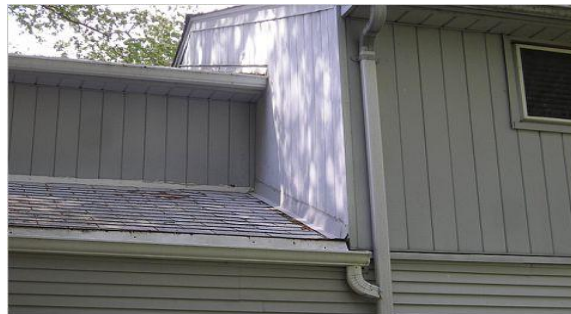
- **Three gutters discharge into one downspout at the rear. This may not be adequate to thoroughly drain roof surface water during extreme weather conditions.**

All three major rear roof areas and gutters ultimately feed one downspout

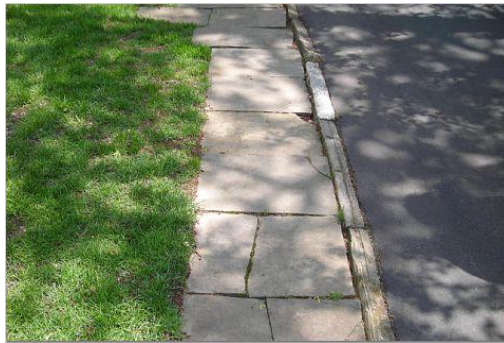
Path Condition: **Irregular and settled surface.**

Irregular path

- **Have irregular and settled sections of the path repaired.**

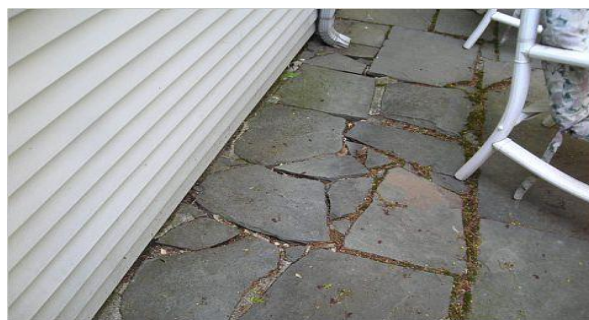
Condition: **Significant cracked and settled areas.**

Patio is cracked and settled

- **Have the cracked and settled sections of the patio re-set.**

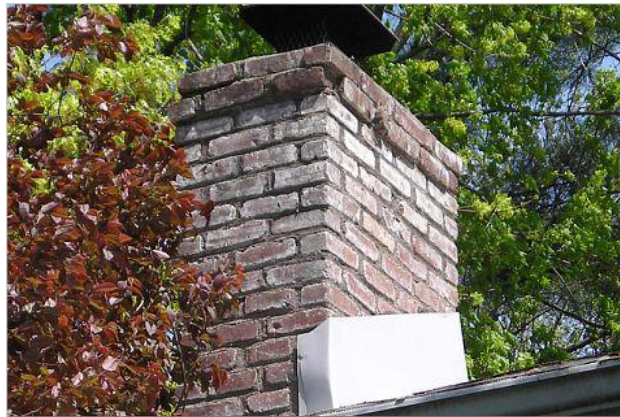
- **Older chimney flashings may be present beneath newer metal flashing wrapped around chimney. This newer metal does not appear to have been adequately cut into the chimney and sealed. Leakage can occur around older or incorrectly installed chimney flashings.**
- **Some loose and soft sections of mortar were seen on the chimney.**

Brick joints appears to be soft and flashing not installed properly

- **The National Fire Protection Association and the National Chimney Sweep Guild recommend that, due to the advanced age or other conditions, a Level-2 Inspection of the chimney and internal components be done to rule out hidden potential safety defects.**
- **Have a qualified chimney contractor service or repair the chimney and flashings as required to assure long term function and safety.**

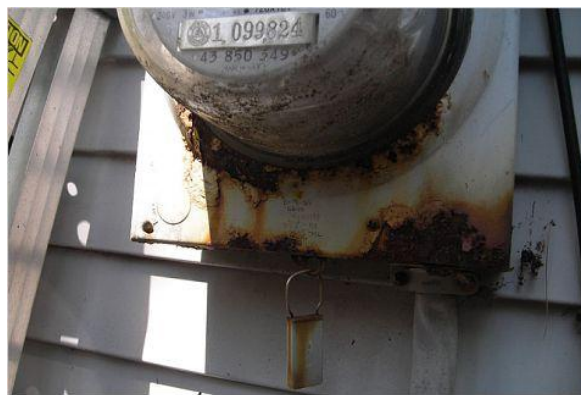
Service entrance location: Overhead. **The meter housing is badly corroded.**

Rusty meter housing

- **Have a licensed electrician upgrade service capacity to 200 amperes, replacing the feed cable and circuit breaker panel in the process.**
- **Have a licensed electrician or the utility company replace the meter housing.**

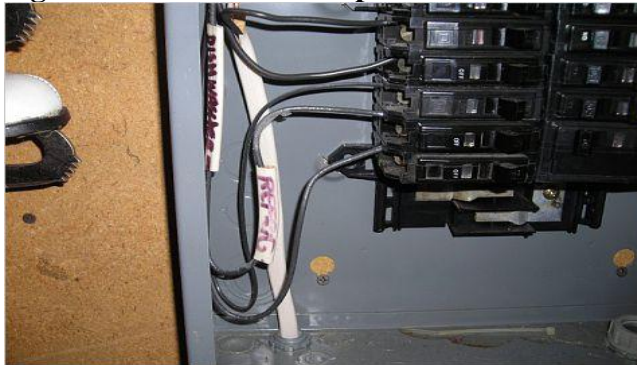
- **Several cables in the panel have been improperly installed, with excess insulation length left on cables in the panel.**

Long white cable – excess insulation in the panel

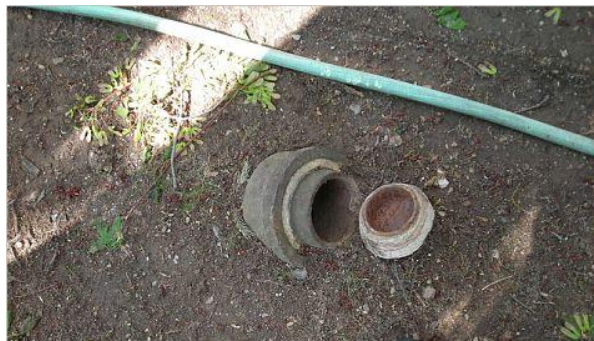
- **An exterior plumbing drain cleanout cover on the right side is open.**

Open cleanout cover

- **Have a plumber replace any older water supply shutoff valves with corrosion or leakage.**
- **Have a plumber replace and secure the open plumbing cleanout cover.**
- **To determine the true condition of the waste and drain pipes we recommend that a plumber inspect them internally using a specialized video camera.**

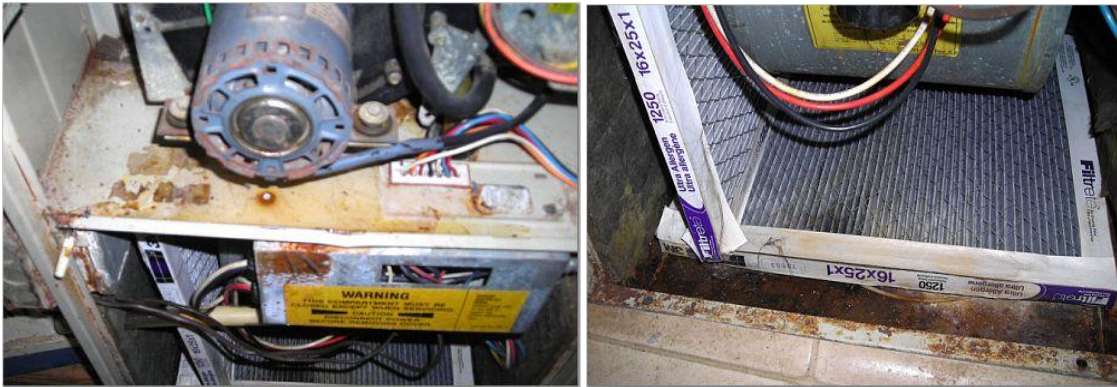
- **The heating system is at the end of its designed service life, and remaining service life is undeterminable by us. In addition, for older equipment the possibility of hidden internal functional and safety related defects is significantly increased.**

- **Significant visible corrosion present.**
- This type of furnace is a high efficiency condensing furnace, which must drain water that condenses from exhaust gas. **Active leakage was occurring from the heating condensate water drain system. Water was leaking into the furnace case, causing corrosion. Water was also leaking down into the filter and return duct system. The water leakage may have caused corrosion to ducts that are within or below the concrete floor slab, but these sections of the ducts were not visible, as they are buried components.**

- **Constant water leakage into filters and ducts may have created conditions conducive to mold growth.**

Water leakage and corrosion inside heating system case
Water has also leaked into the filters and sub-slab ducts

- **As this furnace is now at the end of its life, has corrosion and is currently malfunctioning (leaking), replacement of the system is now due, and should be performed on a proactive basis, before total system failure or unsafe condition develops.**
- **If replacement is not immediately done, repair of condensate water system leakage must be done, as well as further evaluation by a qualified specialist evaluation to assure that hidden defects or safety related issues are not present.**
- **Further evaluation of heating ducts for any corrosion damage and/or mold conditions caused by the leakage.**
- **A service contract to cover future maintenance and repairs to the heating system.**
- **See the Mold section of this report – chronic wet conditions may have been present in duct work, creating conditions conducive to mold growth.**
